THIRD ENDORSEMENT on H&MS-31 AAR ser 1-58 concerning FJ-3
BuNo. 135907, occurring on 24 April 1958, pilot HANSEN

FIRST ENDORSEMENT on Headquarters and Maintenance Squadron 31
AAR Serial 1-58 concerning Bureau Number
135907 accident occurring 24 April 1953,
Pilot First Lieutenant HANSEN

AIRCRAFT ACCIDENT REPORT

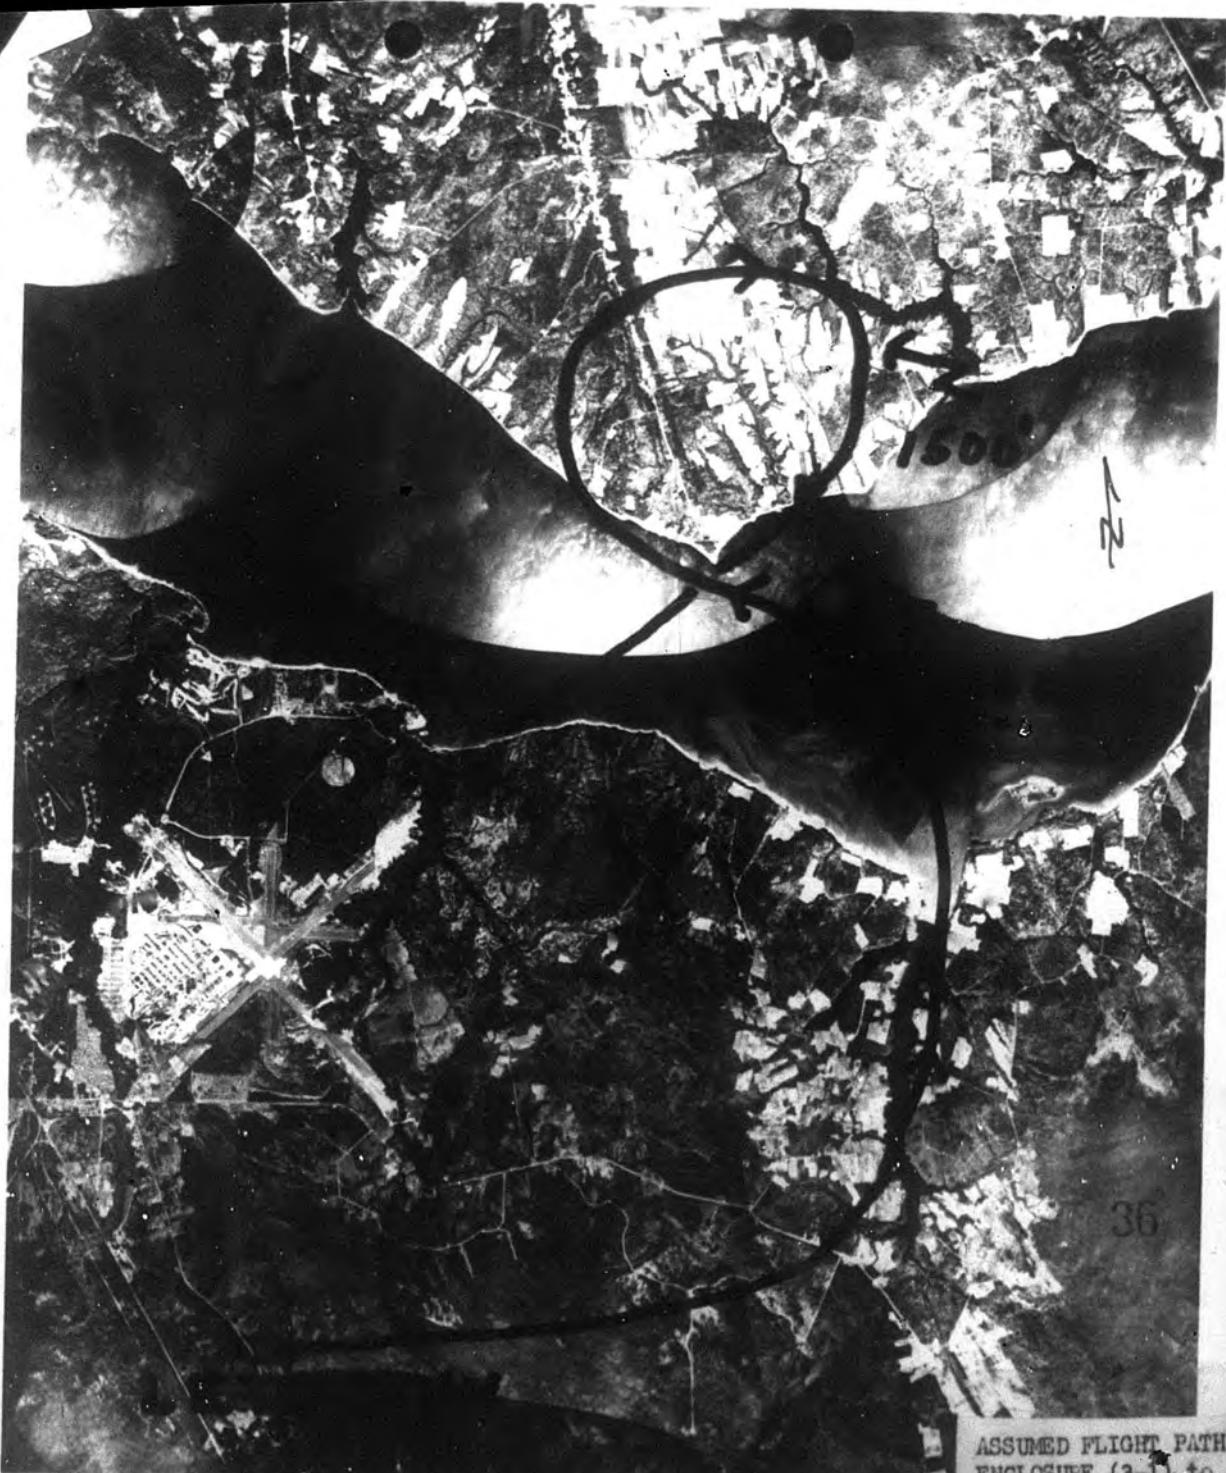
ASSUMED FLIGHT PATH
ENCLOSURE (3-1) to
H&S-31 AAR 1-58

The Board believes that vertigo could possibly be the cause of this accident. The left turn, held for almost 360 degrees in the letdown, level flight for approximately fifteen seconds, then a right 270° turn, which HANSEN probably had not anticipated, into a known dark area, (vicinity of Minnesota Beach) are definite prerequisites for vertigo or disorientation. However, the Board concluded that had HANSEN encountered vertigo he would not have been in position on (b)(6) right wing approaching for initial as all witnesses report. Also as the bank was leveled off initial, lights from MC.S. Cherry Point would be visible for reorientation. The Board believes that had a 360° turn around the lighted airfield to lose altitude been used, in lieu of the right 270° turn, it would have lessened the possibilities of vertigo. The Board also believes that a person suffering from vertigo would be concerned with control of the aircraft and would not make a radio transmission of his difficulty. No emergency transmissions were made.

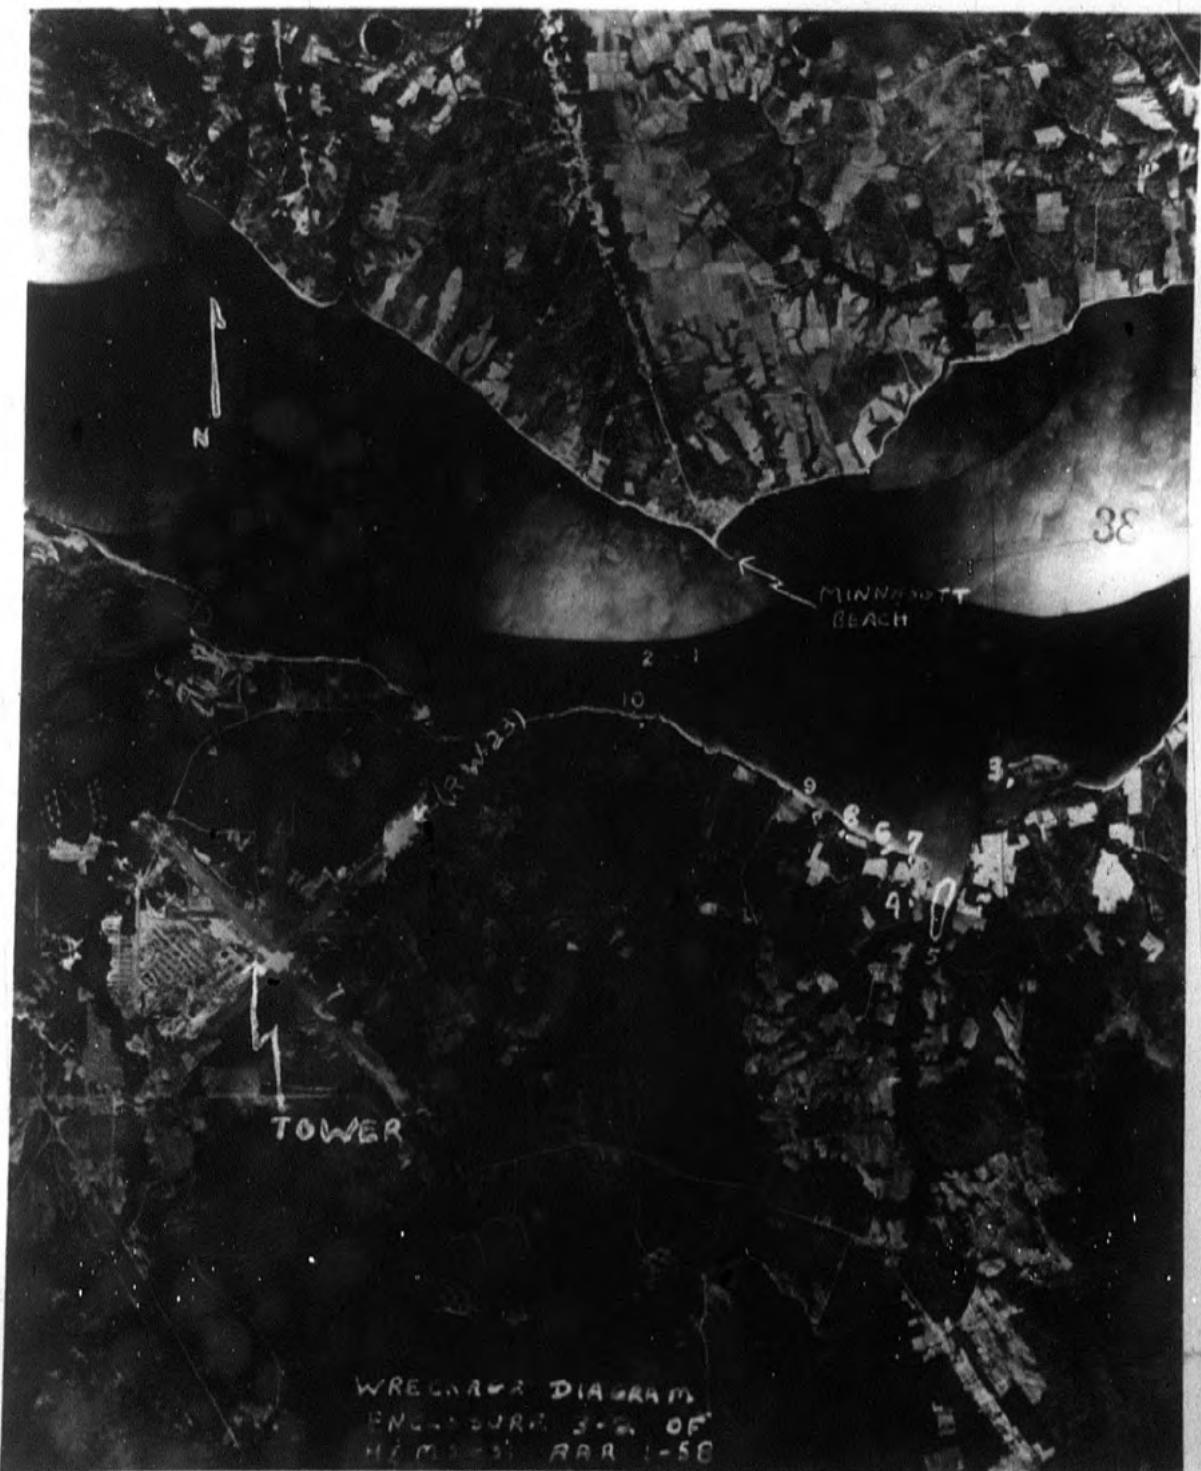
1. 2300 - 24 April 1958
Knee pocket w/maps,
Hi Alt RadFacs, VMF-251 check list
2. 0200 - 25 April 1958
Jet West letdown handbook
3. 0700 - 25 April 1958
HMS-31 cross country packet
4. 0800 - 25 April 1958
Parts of human remains,
VOR RadFacs
5. 1100 - 25 April 1958
FJ-3 Handbook
Pieces of earphones
Part of civilian coat
6. 1200 - 26 April 1958
Part of an FJ-3 float valve
7. 1400 - 26 April 1958
Parts of human remains
8. 1500 - 27 April 1958
Part of an FJ-3 left landing
edge float valve
9. 1530 - 27 April 1958
Part of a Mae West signal pocket
10. Time unknown, FJ-3 headrest cushion
